Manhole Inspection Summary

Manhole # S53W1_003MH

Insp Date: **5/29/08 11:01 AM**

Location Address: **1901 Chesapeake Ave.**

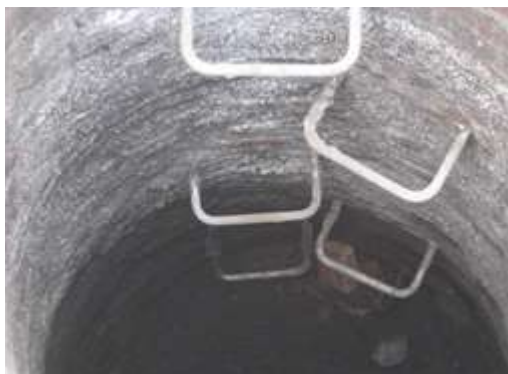
Steps

Count: **6** Missing: **0** ☐ Corroded

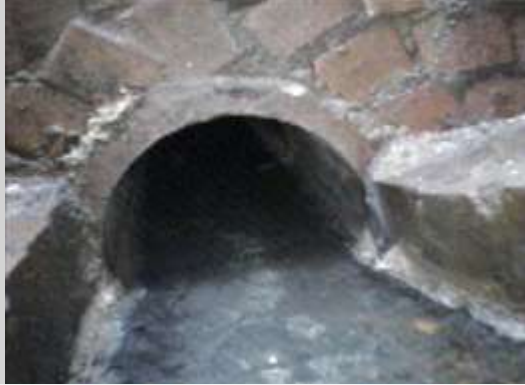
12 O'Clock Outflow

10 in. Circular Gravity Sewer
Pipe Out @ 12 O'Clock

Pipe Height: **10.8** (in.) Rod and Bar (Angled)
Pipe Material: **Clay** ☐ Pipe Lined
Invert Depth: **12.40** (ft.) Flow Characteristics: **Fast**
Deposits: ☒ None ☐ Mud ☐ Sludge ☐ Debris ☐ Grease
Silt Depth: (in.) Deposits Extent:
Infiltration: **None** Pipe Seal Cond: **Sound**

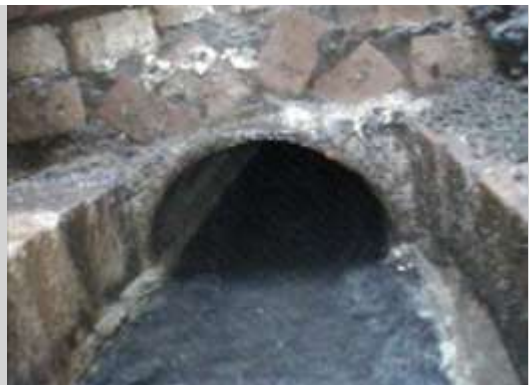
6 O'Clock Inflow

10 in. Circular Gravity Sewer
Pipe In @ 6 O'Clock

Pipe Height: **9.6** (in.) Rod and Bar (Angled)

Infiltration: **None** Pipe Seal Cond: **Sound**
